WL-TR-93-2036

# HIGH TEMPERATURE HYDRAULIC SEALS

K. R. Williams  
McDonnell Douglas Aerospace  
Transport Aircraft  
3855 Lakewood Blvd  
Long Beach, CA 90846-0001

Final Report for Period October 1987 - November 1992

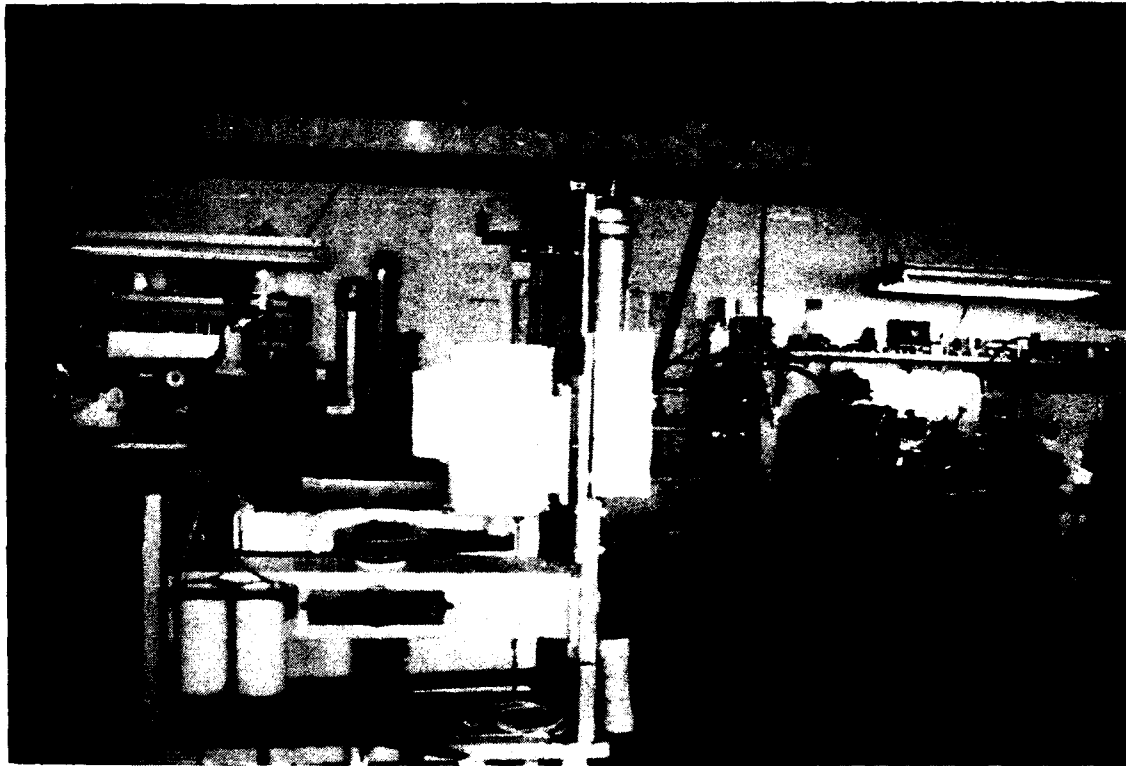
FIGURE 10 - VIEW OF PRE-SCREEN TEST FIXTURE

Figure 10 is a photograph of the test fixture. In this view the dither mechanism can be seen.

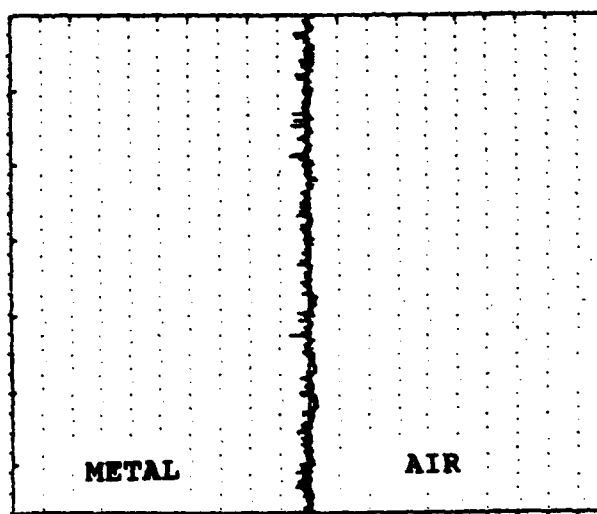
Ra = 1.0 uin  
 Rt = 15.0 uin  
 Rz = 8.2 uin  
 Rtm = 11.2 uin  
 Rzm = 8.0 uin  
 Rq = 1.5 uin  
 Rp = 3.8 uin  
 Rv = -11.2 uin  
 Rpm = 3.0 uin  
 Rvm = -8.2 uin  
 Rsk = -1.260  
 Rk = 7.680  
 Ra = .000 1 in  
 Ram = .000 5 in  
 Ria = .000 5 in  
 Rda = .013  
 HSC(0uin,10uin)=0  
 PC(05) = 32  
 PC(10) = 0  
 PC(25) = 0  
 PC(50) = 0  
 PC(500)= 0  
 Rcp% h (5uin)=100%  
 Rtp% h (5uin)=0%

\*Horz.Scale .0100 in/div  
 >Vert.Scale 10.00 uin/div +  
 Vert. Mag.: 20,000x  
 Sample Interval: 39 uin
